**CASTLEMAINE LANDCARE GROUP
FOREST CREEK WATERWATCH
WATERWAY HEALTH MONITORING PROGRAM**

“RIVER HEALTH SNAPSHOT
REPORT” 2019-2020

WATERWATCH MONITORING FOREST CREEK
SITE NC_FOR650
COLLES ROAD BRIDGE, MOONLIGHT FLAT

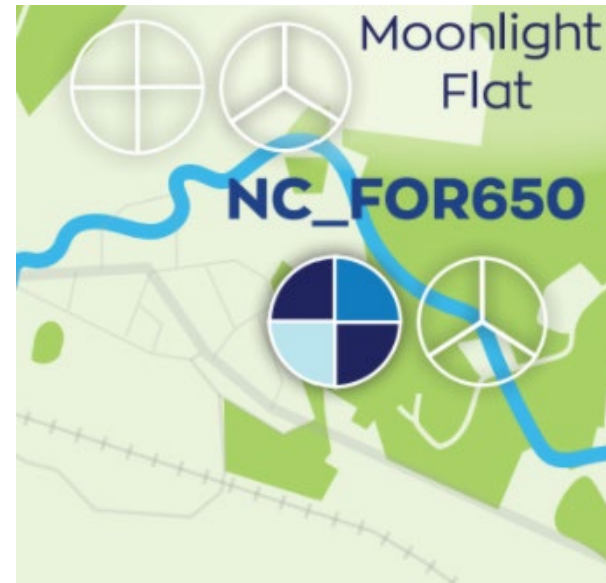
Water Quality Colour Coding

Sites have been colour coded and interpreted as follows:

-  
Good: Water quality is acceptable and has minimal impacts on aquatic ecosystem health.
-  
Moderate: Water quality and aquatic ecosystem health are moderately impacted.
-  
Poor: Water quality and aquatic ecosystem health are largely impacted.

pH
 Turbidity

Electrical conductivity
 Reactive phosphorous

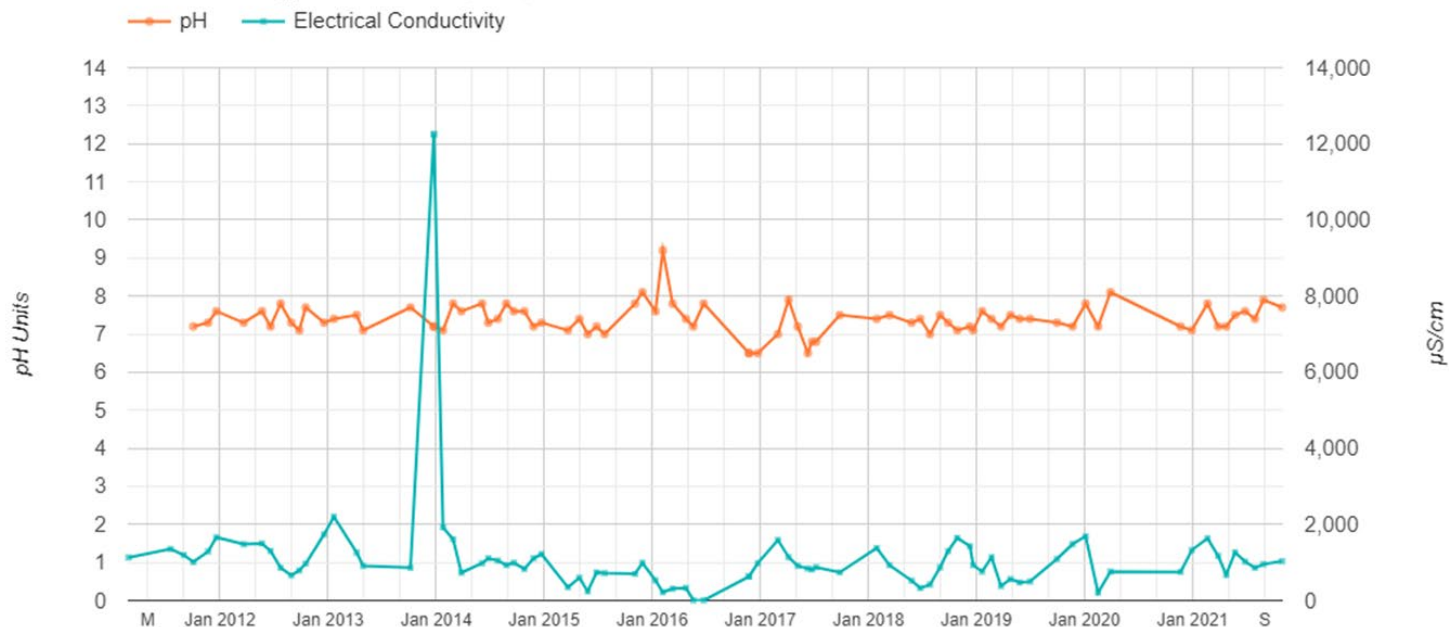
Forest Creek @ Colles Rd bridge Physico Chemical Tests 01-01-2011 - 09-05-2022

pH – basic /neutral / acid
 EC – salinity
 P – Phosphate nutrient
 NTU – turbidity or muddiness

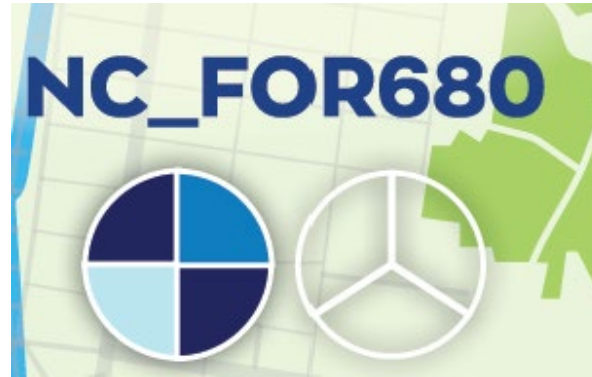
Water Quality Colour Coding

Sites have been colour coded and interpreted as follows:

-   **Good:** Water quality is acceptable and has minimal impacts on aquatic ecosystem health.
 -   **Moderate:** Water quality and aquatic ecosystem health are moderately impacted.
 -   **Poor:** Water quality and aquatic ecosystem health are largely impacted.
- pH
Turbidity
-  
- Electrical conductivity
Reactive phosphorous

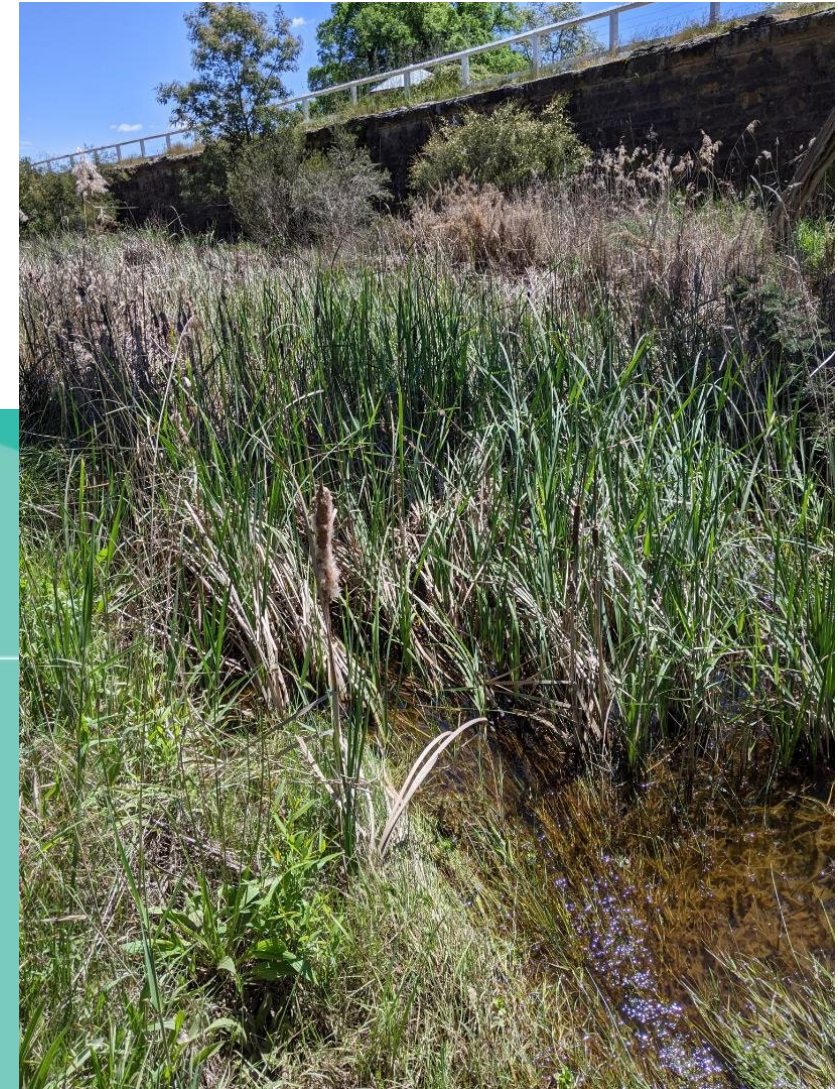
NCCMA Water health & Waterbug surveys 2019

gravel road that crosses the creek. Interestingly, NC_FOR999 indicated low turbidity values which is surprising due to its proximity to the highway and train line. It was assumed runoff from here would (negatively) influence the site's turbidity.

There were elevated salinity levels across each site which may be linked to historical land clearing and agricultural practices. The concentrations of reactive phosphorous were considered moderate overall and were considered good at both NC-FOR650 and NC-FOR680. The elevated readings for Forest Creek were driven by NC-FOR999, which may be linked to runoff from nearby roads, but is more likely being influenced by a phosphorous source upstream. Finally, pH was within a good range for all sites and remained relatively consistent across the sampling period.

Waterbug monitoring indicates poor taxa richness, EPT and SIGNAL scores, which may be driven by the overall high turbidity. Additionally, site specific factors such as lack of riparian vegetation and instream habitat are strong drivers for instream ecological condition. More data is needed to get a better picture of ecological condition. Further sampling will also provide a better insight into the health of the waterway in line with stream and revegetation works.

Phos (Mg/L)	pH	EC (Us/cm)	Turbity (NTU)	Waterbug Taxa Richness	ALT EPT	Signal Score
0.06	7.5	1758.5	74.3	12.5	1.5	3.5
